Comanche Creek Morphology & Riparian Vegetation Monitoring Report

June 2005

Prepared by Steve Vrooman
Cuchilla Blanca Ecology

Rosgen Level II and Vegetation Monitoring in the Middle and Lower Reaches of Comanche Creek Monitoring, June 2005

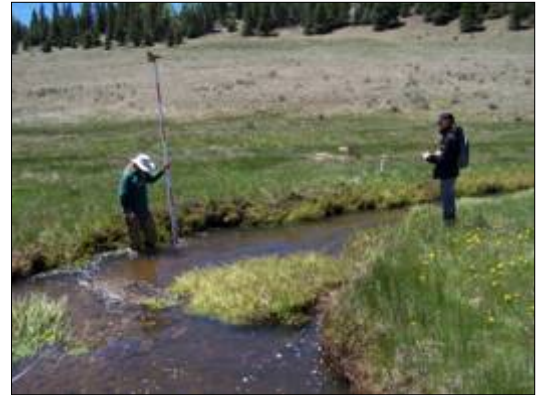
Rosgen Level II monitoring at the Large Elk Exclosure Site:

This data was taken from Pittenger Cross-Section number 1. The pebble count was taken every 60 feet from the top of the reach (10 points between banks).

Parameter	value
Bankfull Width	13
Mean depth	1.6
Bankfull Area	21.2
W/D ratio	8:1
Max Depth	2.0
Flood prone width	155
Entrenchment	11.9:1
D50	8mm
Water surface slope	0.7 %
Sinuosity	Need valley distance from GIS
Stream Type	E4

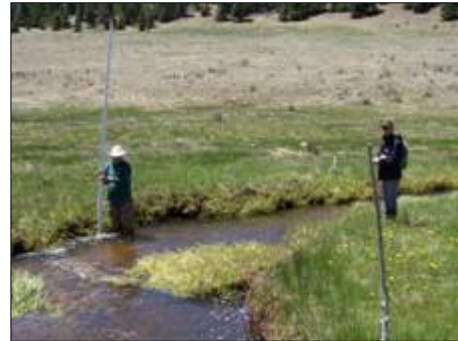
Rosgen Level II monitoring at the Lower Site, 1.2 miles up from Costilla Creek:

This data was taken from Cross Section 3. The pebble count was taken every 60 feet from the top of the reach (10 points between banks).

Parameter	value
Bankfull Width	11.2
Mean depth	1.1
Bankfull Area	11.9
W/D ratio	11:1
Max Depth	1.6
Flood prone width	134
Entrenchment	12:1
D50	28mm
Water surface slope	1.16%
Sinuosity	Need valley distance from GIS
Stream Type	E4
