Comanche and Cordova Creeks Watershed  
Restoration Action Strategy, Education, and Restoration  
**Project FY01-Q NUMBER C9-996101-009-01**  
**Contract Control # 02 667 5000 0007**

**FINAL REPORT**

The Quivira Coalition

October 31, 2005

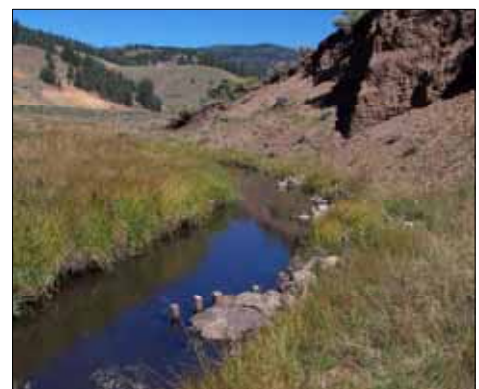
**Vanes** are wood post or rock structures installed at strategic locations in Comanche Creek to direct stream flow left or right, away from eroding banks to reduce sediment production and promote streambank vegetative growth. ***Fifty-six vanes are designated to be installed along the lower reach.***

- 3 were installed as a demonstration project in 2003
- 3 were installed as a demonstration project in 2004
- 8 were installed by RMYC 2005
- 3 were installed by Albuquerque Wildlife Federation 2005
- 39 will be installed July-Sept. 2006

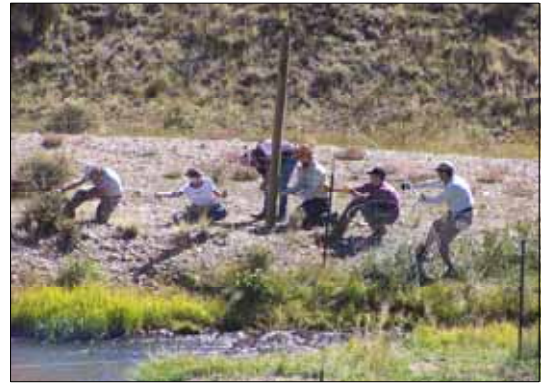
**Mini-Exclosures** are small fenced areas installed in strategic places and designed to increase woody streamside vegetation and protect overhanging banks from elk and livestock grazing and trampling. Desirable woody vegetation includes willows, cottonwoods, and alders. ***Fifty-two mini-exclosures are designated to be constructed along the lower reach.*** Due to a flood event in May of 2005 most of the mini-exclosures were damaged or all the way down. New specifications for building these exclosures were developed and various volunteer groups came out in record numbers to help rebuild about 42 structures.

- 5 were installed around 1993 and survived the high water very well; some repair is needed
- 42 structures were either fixed, added on to, re-built or newly built July-September 2005
- 5 exclosures will need to be finished in 2006
- 1 exclosure is to be removed
- There is one very large exclosure in the middle reach just west of Gold Creek and (some repair work was done where the fence crosses Comanche, but there is a downed section on the SE corner), 4 mini-exclsoures, and one downed cattle exclosure. None of the exclosures in the middle reach were worked on.

One of the largest challenges was the 10 year flood in that occurred in May of 2005. Up to 80% of the exclosures were torn down or damaged. As part of the second Comanche Grant, each exclosure was surveyed and re-designed in accordance with hydrological patterns. A new specification sheet was created so that all the different groups that help build exclosures would be on the “same page”. A record number of volunteers came out in July, August and September to re-build. There are only 5 remaining to finish in 2006.

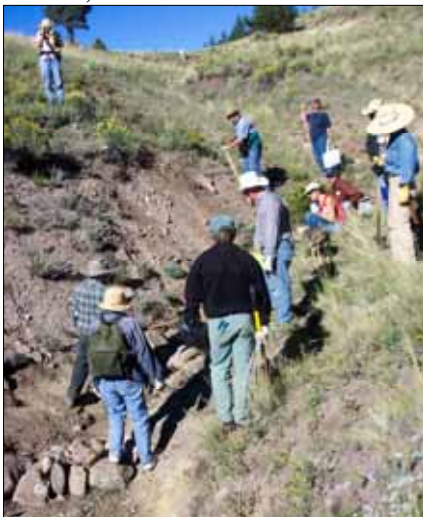
**Upland Erosion Control Treatments** such as Rock or log structures are installed along side drainages of Comanche Creek. These are designed to slow the movement of water, collect soil, nourish vegetation and prevent sediment from entering the creek. Examples include One Rock Dams, Rock Bowls, and other structures.

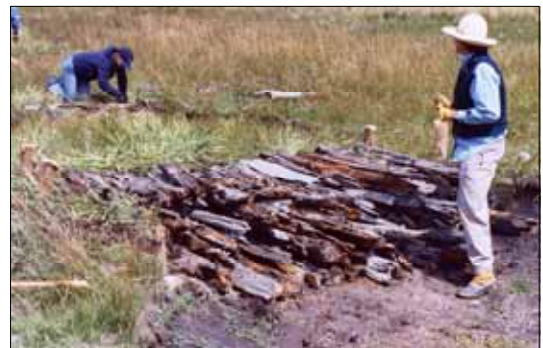
One hundred and seventy-one restoration treatments were installed within the Comanche Creek Watershed as of September 2005

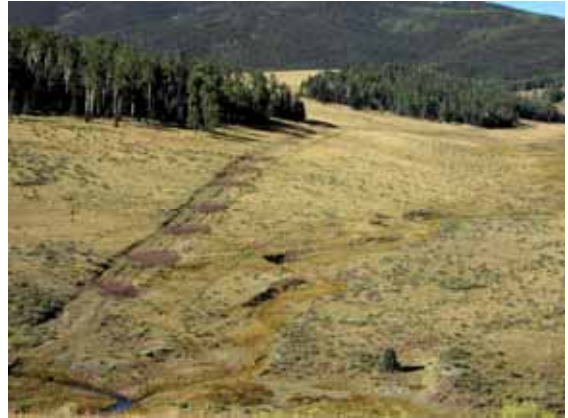
**Road Sediment Control Treatments** direct runoff from the road surface onto the landscape which will filter sediment and reduce stream turbidity. Different kinds of treatments have been installed throughout the watershed to improve drainage. Examples of treatments called Rolling Dips spill water onto vegetative buffer zones instead of directly into the creek. Examples are located on

closed roads along Chuckwagon creek, Holman creek, and Gold creek. Road drainage treatments completed in 2004 include:

- 0.2 mi. road completely restored to natural contours.
- 1 stream crossing rehabilitated to restore natural floodplain banks and decrease sediment from FS Administrative use road.
- 5.2 miles (approx.) stabilized with rolling grade dips & waterbars.
- 2 culverts removed that were affecting the stream channel.
- 1 culvert plugged - not needed for road drainage and better handled surface flows with a grade dip.
- 2 culverts functionality improved with install of associated grade dips.
- Holman Creek (old timber sale access road) 1.3 miles (approx.) stabilized with rolling grade dips & waterbars.
- Gold Creek 1.8 miles (approx.) stabilized with rolling grade dips & waterbars.
- Chuckwagon Canyon 3.4 miles (approx.) stabilized with rolling grade dips & waterbars.
- 1.0 miles road completely restored to natural contours.

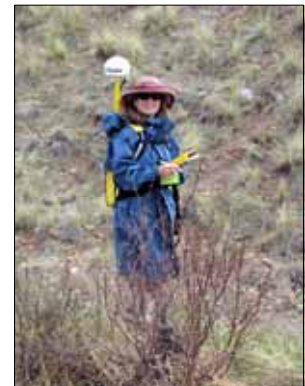
Both sides of lower Comanche Creek (below where Little Costilla drainage) were mapped and locations were marked for map points that included: vanes, willows, cottonwoods, mini-elk enclosures etc. (Task 13)
